2014 Outstanding Underground Project

Robinson Creek Tunnel Fire

2014 Outstanding Repair & Rehabilitation Project

Liberty Tunnel Arch Restoration with a Shotcrete Alternative

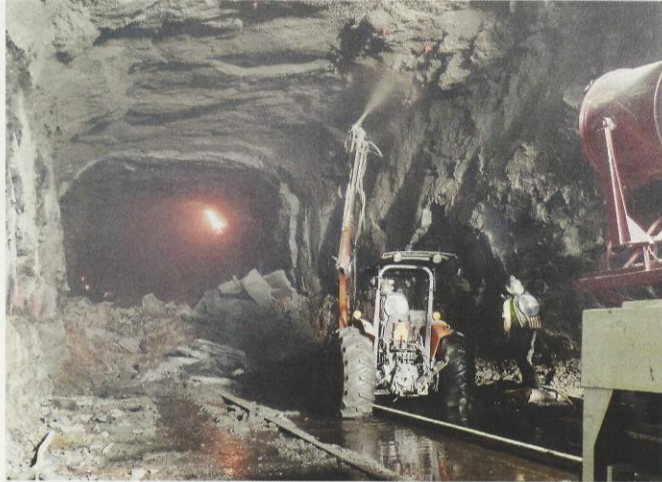
Fig. 2: Initial shotcrete roof support

As crews advanced into the tunnel, shotcrete was used to establish the initial structural support and safely assess the condition of the tunnel interior (refer to Fig. 2).

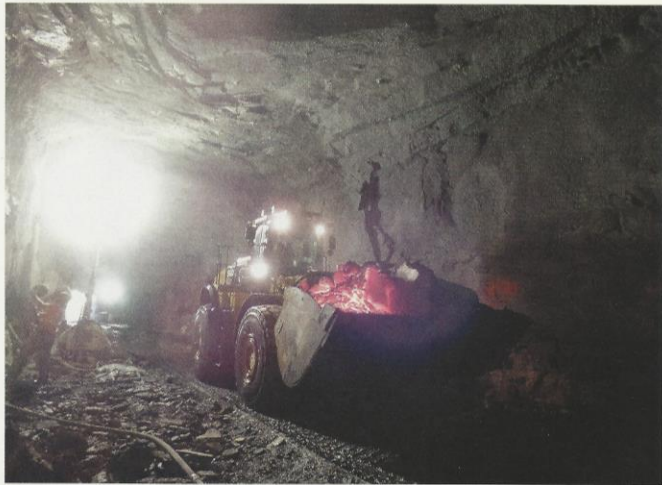
Fig. 3: Muck removal with loader

LRL advanced through the tunnel in about 30 ft (9 m) long reaches. This was done by pulling invert muck back toward the open portal with a trackhoe and removing it with a front loader (refer to Fig. 3). Crews then moved forward safely scaling the roof and sidewalls. When ground temperatures and air quality conditions allowed, ACI Certified Nozzlemen placed shotcrete on the ceiling/walls with hand nozzles and a robot to establish initial support. When applied to the coal seams, the shotcrete effectively halted degassing and extinguished visible flare-ups. The high temperatures and CO levels within the tunnel diminished as the shotcrete was applied. As workers cooled down the muck pile and hydroscaled the ceiling and walls, the ground kept “popping” due to rapid cooling. The shotcrete significantly slowed down the cooling process of the rock, and enabled workers to safely press on. LRL workers used an off-track rubber tire shotcrete operation for the exploration phase because the rail inside the tunnel was deformed. Equipment included a robot tractor mounted arm manufactured by Shotcrete Technologies, a batch plant, and a concrete pump. LRL and the balance of the project team worked 24 hours a day for 24 days to complete this exploration. In this time, LRL installed three-hundred thirty-two 8 ft (2.4 m) long CT-bolts supplied by DSI Underground and placed 100 yd³ (76 m³) of shotcrete.

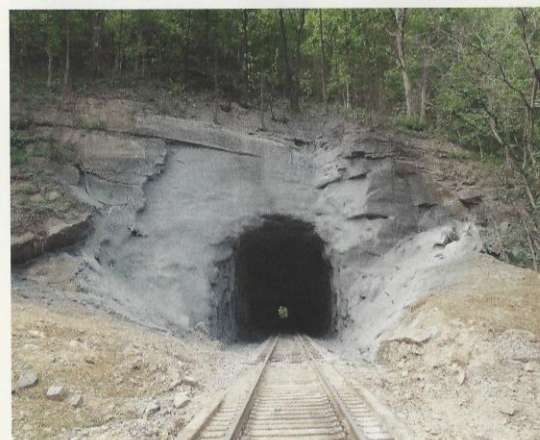
Fig. 7: West portal—final liner

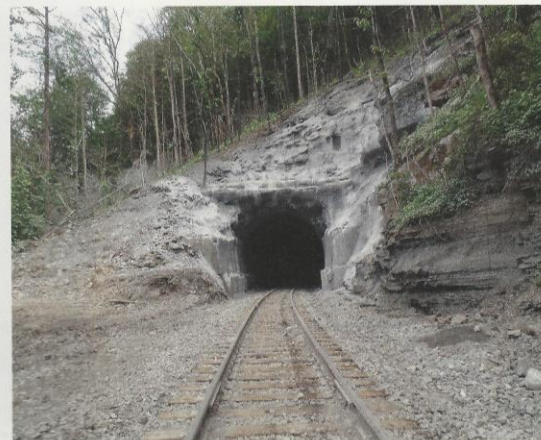
Fig. 8: East portal—final liner

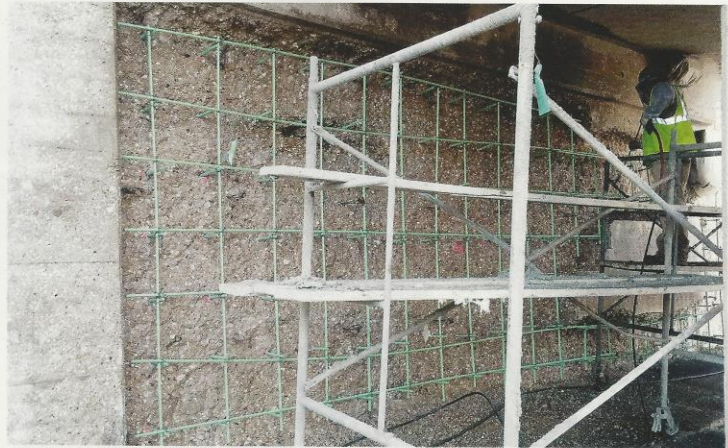
Fig. 1: Repair areas were found to be not only much larger in the field but also deeper than was called out on the plans and also lacking any reinforcing bar

With frost already present and frigid cold temperatures soon to be upon Chicagoland, ACR devised a plan to keep the project moving forward through the winter months. This plan consisted of performing the necessary concrete removals at the bridge locations followed by fully enclosing and heating the structures for shotcrete work to proceed. Along with a late start in the year and the cold weather setting in quickly, this project had a variety of obstacles, including access into heavily congested neighborhoods and residents' properties, repairs during limited closures of main thoroughfares, and a structure that was in much worse shape than originally anticipated (Fig. 1).

Upon commencement of the project, ACR realized that the bridges were in far worse condition than shown on the plans. Quantities immediately began increasing, as did the depths of the repairs, due to the fact that these walls were constructed with 1 in. (25 mm) unwashed river rock aggregate and without reinforcing steel. It was imperative to maintain excellent communication with the general contractor and the owner's engineers to verify work to be done and any additional repair steps to be taken, such as the addition of reinforcing bar, shoring, and identifying areas of complete deterioration requiring full replacement.

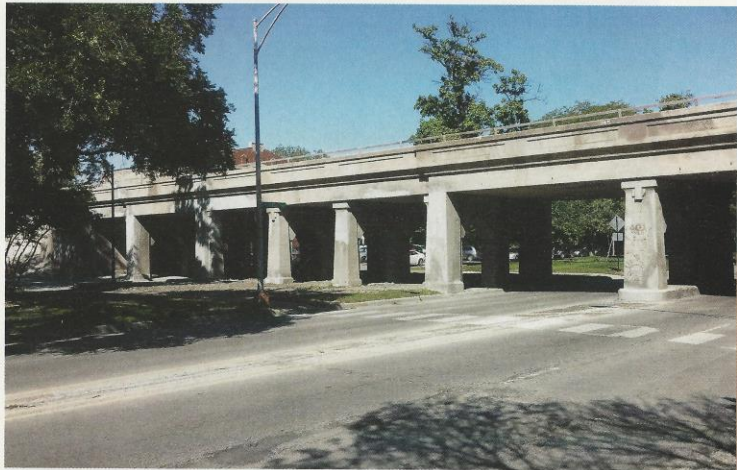
Fig. 2: Repaired 11 piers spanning 250 ft (76.2 m) over six lanes of traffic

encompassed the entire substructure including the wing walls, abutments, columns, and parapets. Each of the 36 bridges crossed two-lane streets, had three piers, and 15 columns. The trail also crossed five arterial streets, each with four lanes of traffic. At these locations there were four piers and 20 columns. At the longest bridge crossing, Humboldt Park Boulevard, it crossed six lanes of traffic, and there were 11 piers and 33 columns (Fig. 2).

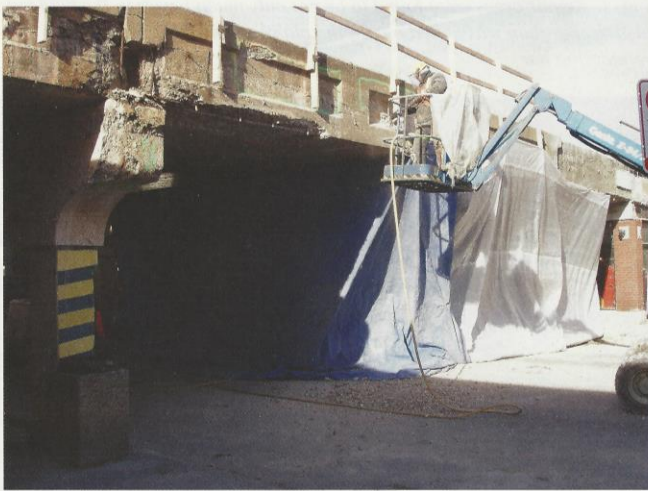
Fig. 4: Heated enclosures were installed on portions of bridge during winter months

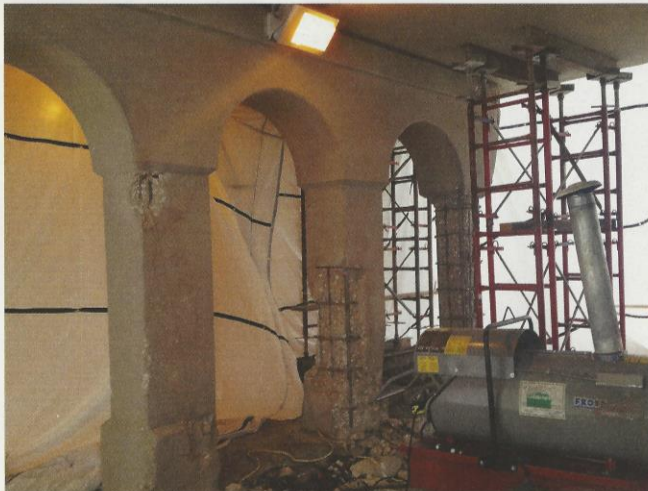
Fig. 5: Large propane heaters kept temperatures inside enclosure within specifications during cold winter months

thermometers to confirm the temperature of the substrate, water, pre-bagged material, and mixed material stayed at or above the specified minimum temperatures. The temperatures were recorded on quality control checklists every hour to document ACR's ability to maintain a high-quality shotcrete mixture. ACR's plan succeeded in providing quality repairs while allowing the project to progress through the brutal Chicago winter.

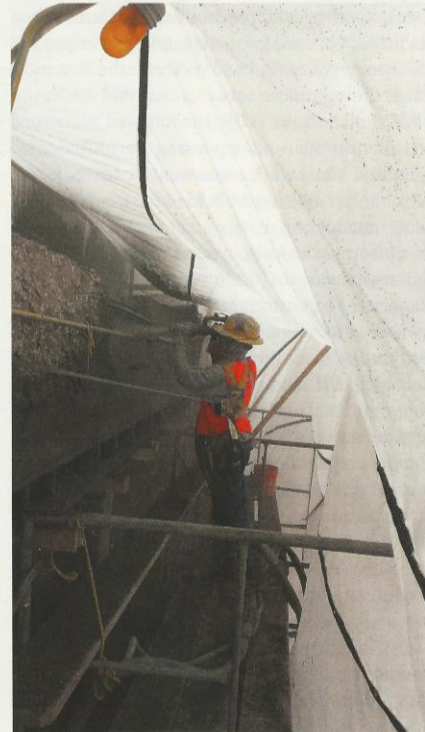
Fig. 6: Shotcrete placement inside a heated bridge enclosure

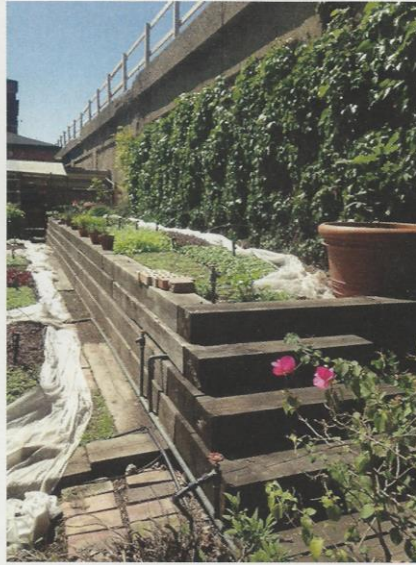
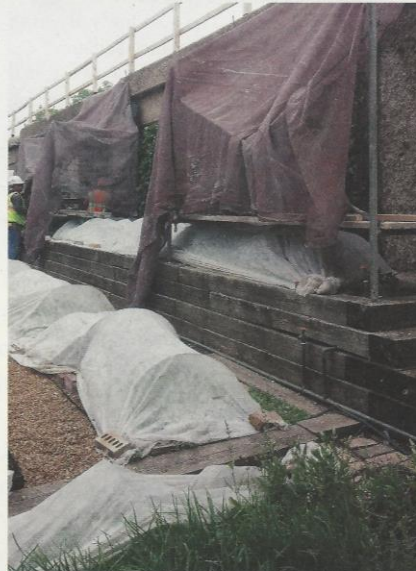
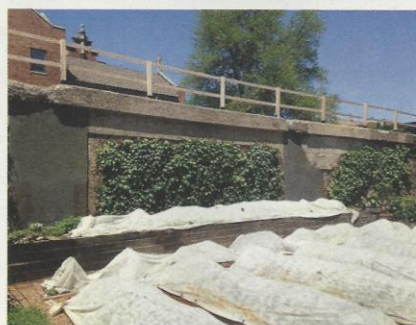
Fig. 7: Elaborate gardens of homeowners required covered repair areas that needed thorough planning, preparation, and coordination

Specifically, one of the yards ACR needed to access housed a picturesque koi pond and an herb garden owned by a well-known chef. This garden is closely tended by a professional gardener, and the harvest is used in several restaurants (Fig. 7). Thus, ACR had to deploy multiple levels of protection for the plants and planters from dust, debris, and overspray. Further, the retaining wall next to this garden was covered in decorative vines, and ACR had to coordinate with the chef's gardener to ensure proper pruning or removal without unnecessary damage to the surrounding foliage. In other areas, ACR had to install temporary framing on the outer edge coupled with protective mesh and tarps to ensure that the shotcrete work was not damaging homes and yards. ACR also encountered an area of retaining wall where the cap was directly above a residential balcony. To perform removals and shotcrete repairs without damaging property below, two stages of protection were deployed. First, ACR installed a fabric tarp along the guardrail of the trail to keep debris from travelling over the side. Additionally, the area designated for repair was framed to ensure that all chipping debris would remain on the trail-side instead of falling to the balcony and property below. This one-sided formwork also gave the nozzleman something to shoot against. As ACR progressed along this 2.67 mile (4.29 km) jobsite, encountering different temperaments of residents, gaining permission to access the repair areas along the retaining walls ran the spectrum of difficulty.

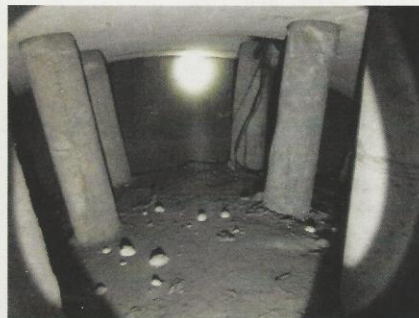
Fig. 6: Embedded hangers in existing void space between main tunnel and ventilation arch wall

Reusability of the existing hangers embedded in the concrete also posed an uncertainty because its usability could only be determined after the demolition of the existing arch wall. The number of deteriorated hangers or hangers which were damaged during the demolition was therefore unknown at the start of construction. Further, sorting out the hangers and replacing the deteriorated ones was considered a time-consuming activity in itself. The hangers also posed an additional hindrance during formwork installation.

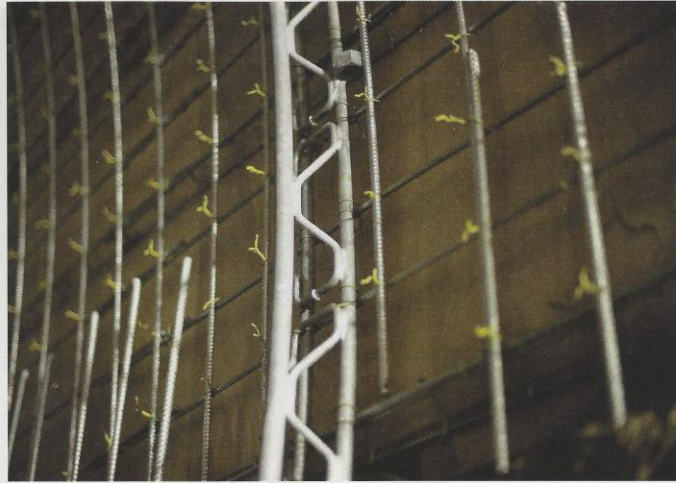
Fig. 8 (left and above): Construction sequence Step 3—lattice girder and extrados reinforcement sidewall sections

Step 3: A light plywood formwork was set up along with first layer of welded wire reinforcement at the extrados (exterior curve of the arch) side of the lattice girder. The center part of the arch was left open to provide access for the construction of the vertical walls. Figure 8 illustrates the erected lattice girders of the arch walls and

vertical wall sections. The center arch section is open to allow shotcreting of the vertical walls. In the back, the suspended section of the arch wall, acting as a ventilation nozzle, which was not discussed in detail in this paper, can be seen.

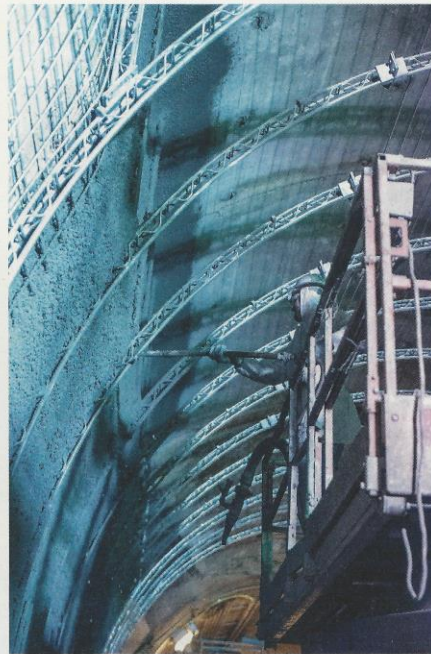
Fig. 9: Construction sequence Step 4—curved and vertical sidewall sections are shotcreted

Step 4: Shotcrete was applied at the rounded and vertical wall sections—excluding the center part. Only the vertical wall sections were completed to full thickness and with both layers of reinforcement, while the intrados layer of reinforcement at the arch wall sidewall was left for later completion. As observed in Fig. 9, the

curved and vertical sidewall sections have been partially shotcreted.

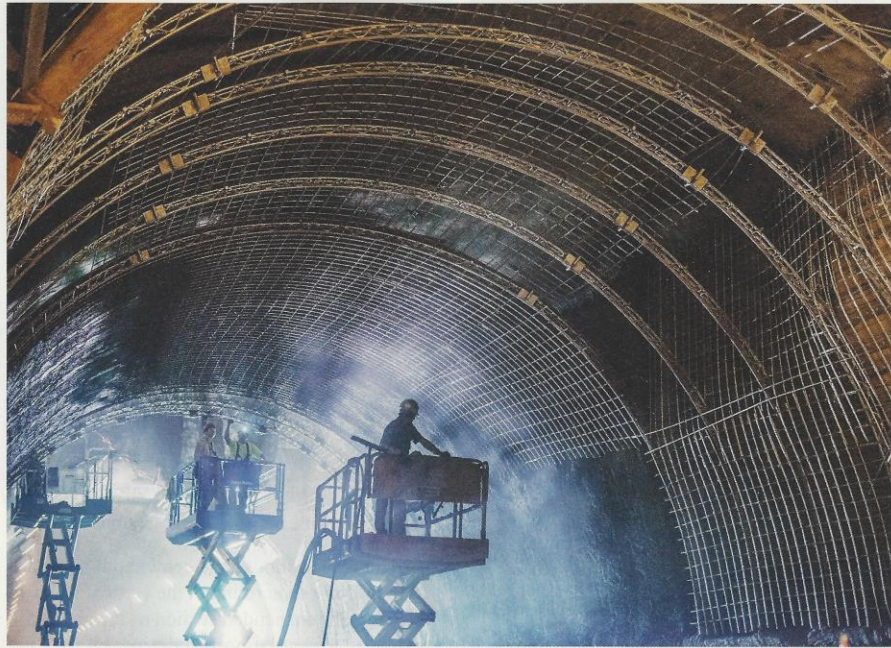
Fig. 10: Construction sequence Step 5—preparation of center arch section

Step 5: The center arch section was closed by installation of the plywood and reinforcement at the extrados side of the arch. As soon as the vertical wall sections were completed, the plywood and reinforcement in the center arch section could be installed and shotcreted, which is illustrated in Fig. 10. After this step, the intrados (interior curve of the arch) level of reinforcement covered by the final layer of trowel-finished shotcrete can be installed.
