PROJECT > I-70 Bridge Deck Repair

I-70 Over West 20th Ave., Denver, CO

PROJECT DESCRIPTION:

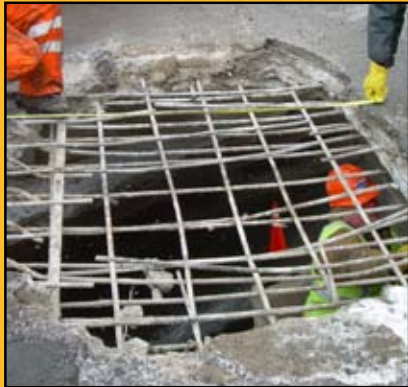
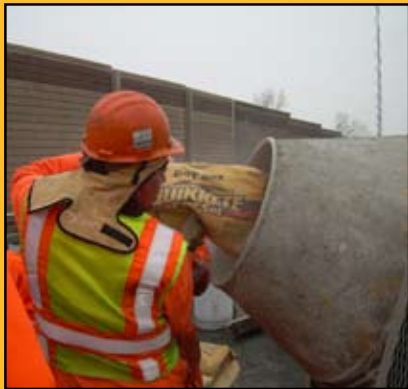
QUIKRETE® FastSet™ DOT Mix was used to repair a 4'X8' bridge deck failure on the westbound lane of I-70 over West 20th Ave.

CDOT replaced damaged rebar and installed a plywood form on the underside of the bridge deck. Following temperature precaution guidelines, CDOT heated the mixing water to 55°F prior to use.

QUIKRETE® FastSet™ DOT Mix achieved an initial set time of 30 minutes (17°F ambient temperature) and exceeded 3,000 psi in 90 minutes after placement. All lanes were open to traffic within 2-1/2 hours of product placement.
