PROJECT > The Miami Woman's Club

Stucco Restoration
Miami, Florida

PROJECT DESCRIPTION:

Complete stucco facade restoration of the historic Miami Woman's Club, originally constructed in 1925.

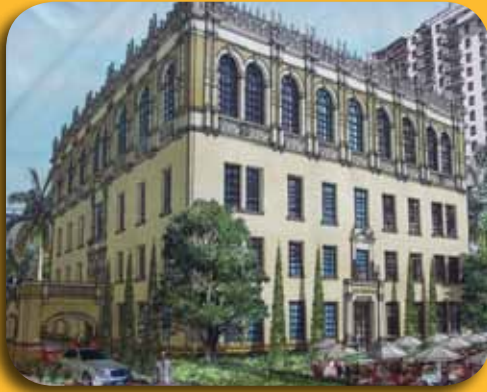
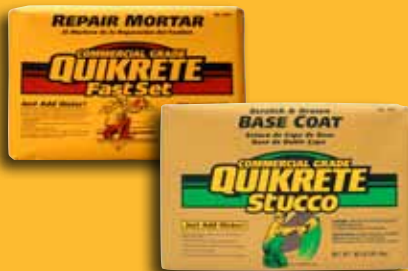
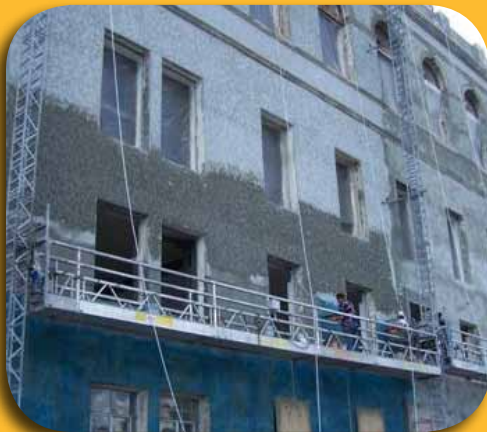
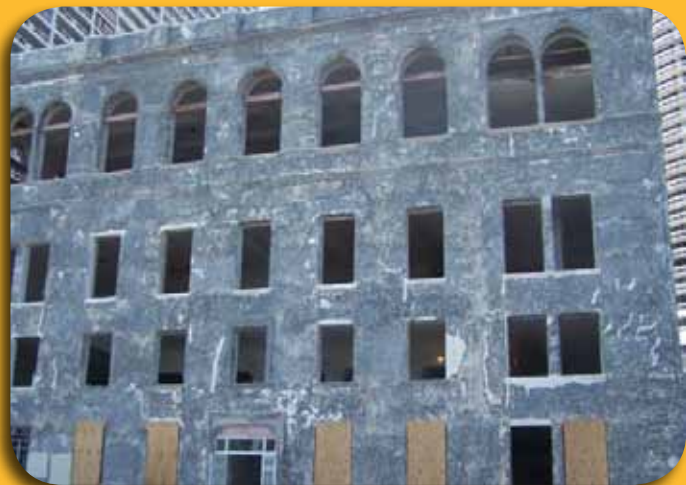
QUIKRETE® FastSet Repair Mortar was used for vertical repairs to damaged window sills and the cement plaster base coat. After the deteriorated original stucco finish was removed, a stucco bonding adhesive was applied to the smooth surface. QUIKRETE® Base Coat Stucco was used to apply a 5/8" thick base coat and texture coat to match the original Mediterranean finish.
